NASA Technical Memorandum 100188

Bonding Lexan and Sapphire to Form High-Pressure, Flame- Resistant Window

BONDING LEXAN AND SAPPHIRE TO FORM HIGH-PRESSURE, FLAME-RESISTANT WINDOW

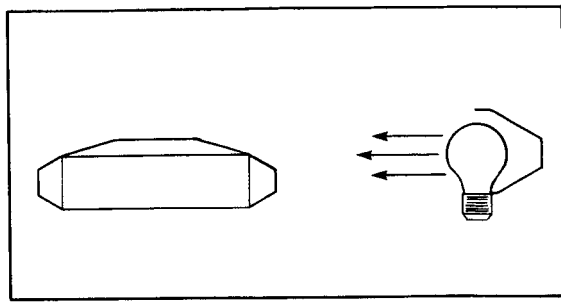
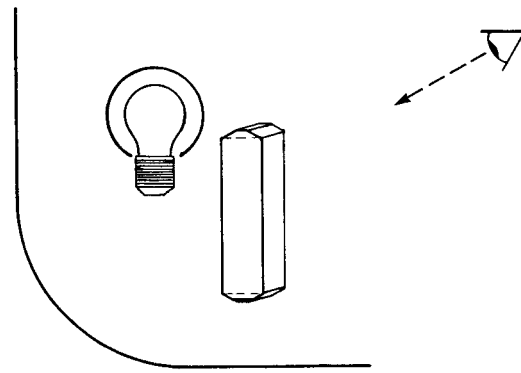
(A) TOP VIEW.

(B) SIDE VIEW.

FIGURE 1. - INSPECTION STATION.

After cleaning, each window was visually inspected and any imperfections in either the Lexan or the sapphire were documented. An inspection station was made with a black background and illuminated with a strong, directional side light (fig. 1). This inspection station allowed observation of very small defects.

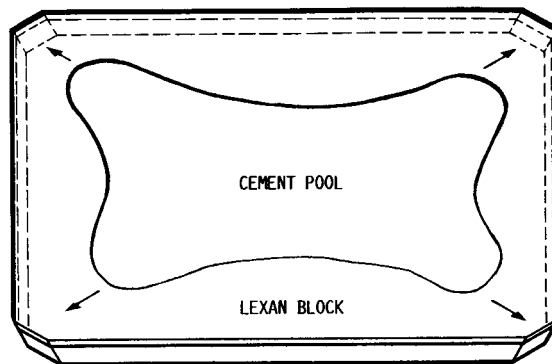
FIGURE 2. - ADHESIVE APPLICATION PATTERN.

The flattest side of the Lexan piece was placed face up on a clean, flat surface. Approximately 15 drops of Norland optical adhesive #68 were applied to the surface in a pattern that had been found to spread evenly (fig. 2). Trapped air bubbles were then removed from the cement, and the cement was allowed to stabilize in order to reduce surface depressions that trap air. The sapphire plate was then lowered onto the surface of the cement, pushing trapped air toward the edges ahead of the contact front (fig. 3). The sapphire plate spread the cement, which formed an oval spot between the surfaces (fig. 4).

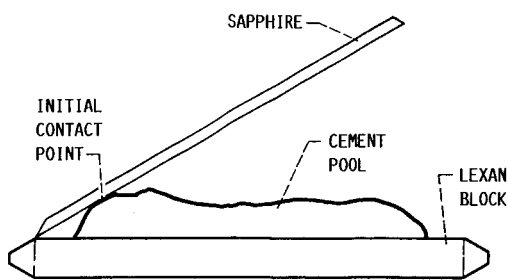
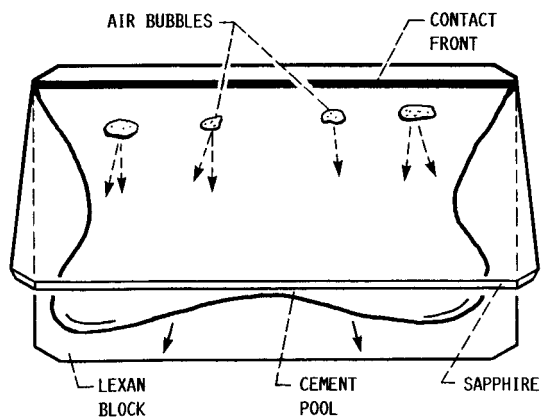
(A) TOP VIEW.

(B) SIDE VIEW.

FIGURE 3. - ASSEMBLY OF LEXAN-SAPPHIRE WINDOW.

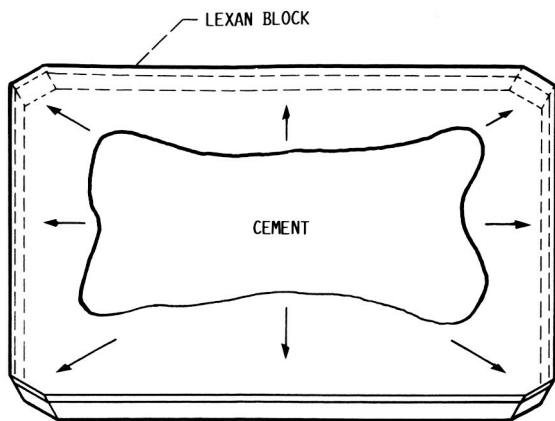
FIGURE 4. - SPREADING OF CEMENT.

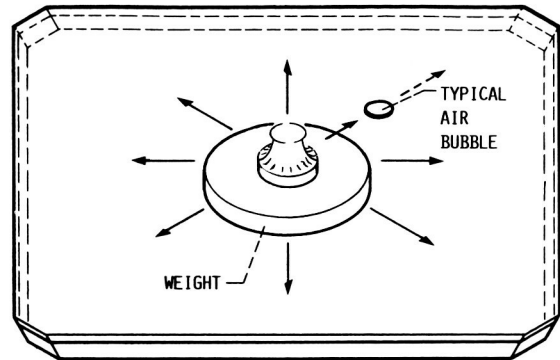
FIGURE 5. - BUBBLE MIGRATION.

Small bubbles often remained trapped between the surfaces. Usually they could be forced out by placing a weight between the center of the sample and the air bubble and moving the weight toward the nearest edge to follow the migrating bubble (fig. 5). It generally took about 1/2 hour to get an even spread of cement between the two surfaces and to remove all the air. The weight of the sapphire material forced excess cement from between the two surfaces. When the cement stopped seeping out and the excess had been removed from the edges, the sandwich was placed into the holding fixture. The fixture prevented the sapphire from sliding around on the cement before it became tacky (fig. 6). The sandwiched materials were then exposed to long-wave ultraviolet light for 10 minutes to set the sample. The light source was a Pen-Ray model

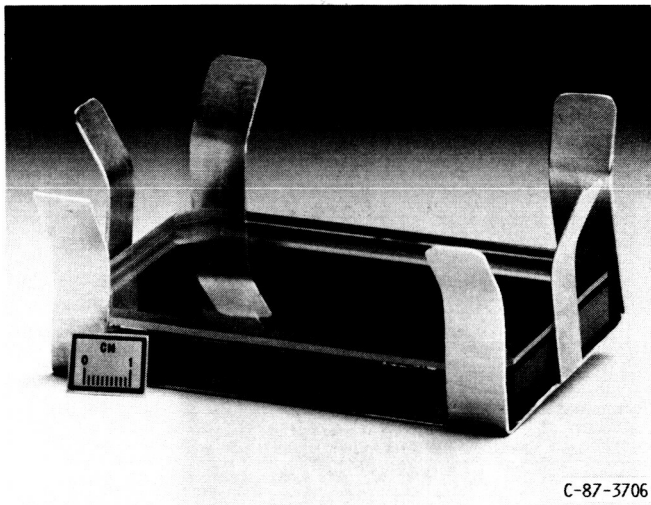
FIGURE 6. - HOLDING FIXTURE.

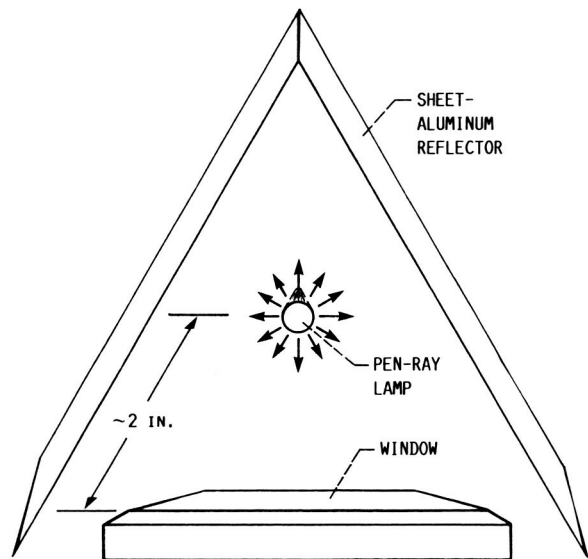
FIGURE 7. - CURING STATION.

SCT-1 placed approximately 2 inches from the sapphire surface. The window was cleaned, inspected, and then exposed to the lamp for 6 hours to cure. During exposure a reflector was placed over the lamp and the window to concentrate the light and to protect personnel (fig. 7).

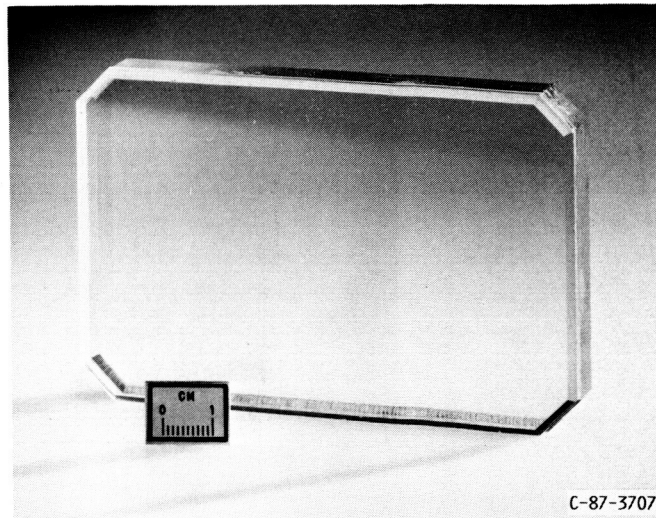
FIGURE 8. - COMPLETED LEXAN-SAPPHIRE WINDOW.

The completed windows (fig. 8) were installed in a pressure vessel (fig. 9) and hydrostatically tested to 60 psig. The pressure vessel was then pressurized with 2 atmospheres of helium and placed in a vacuum chamber evacuated to 10^{-5} torr. A leak check was conducted.

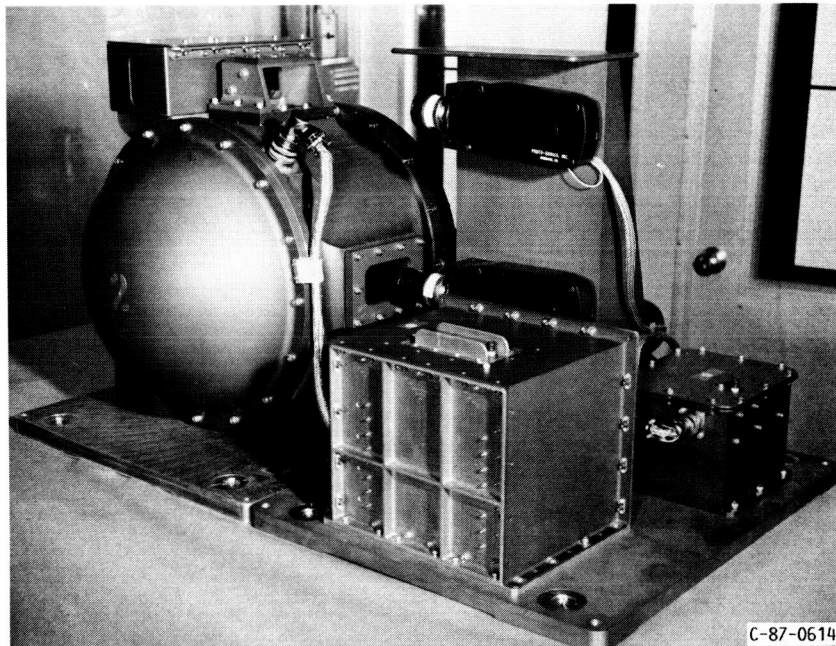
FIGURE 9. - PRESSURE VESSEL.
